Report on a Fatal Accident
and Fire at the
West London Terminal
of Esso Petroleum
Company Limited
on 1st April, 1967

H. K. BLACK, B.Sc., Ph.D., D.I.C., F.R.I.C.

H.M. Chief Inspector of Explosives

6th September, 1967

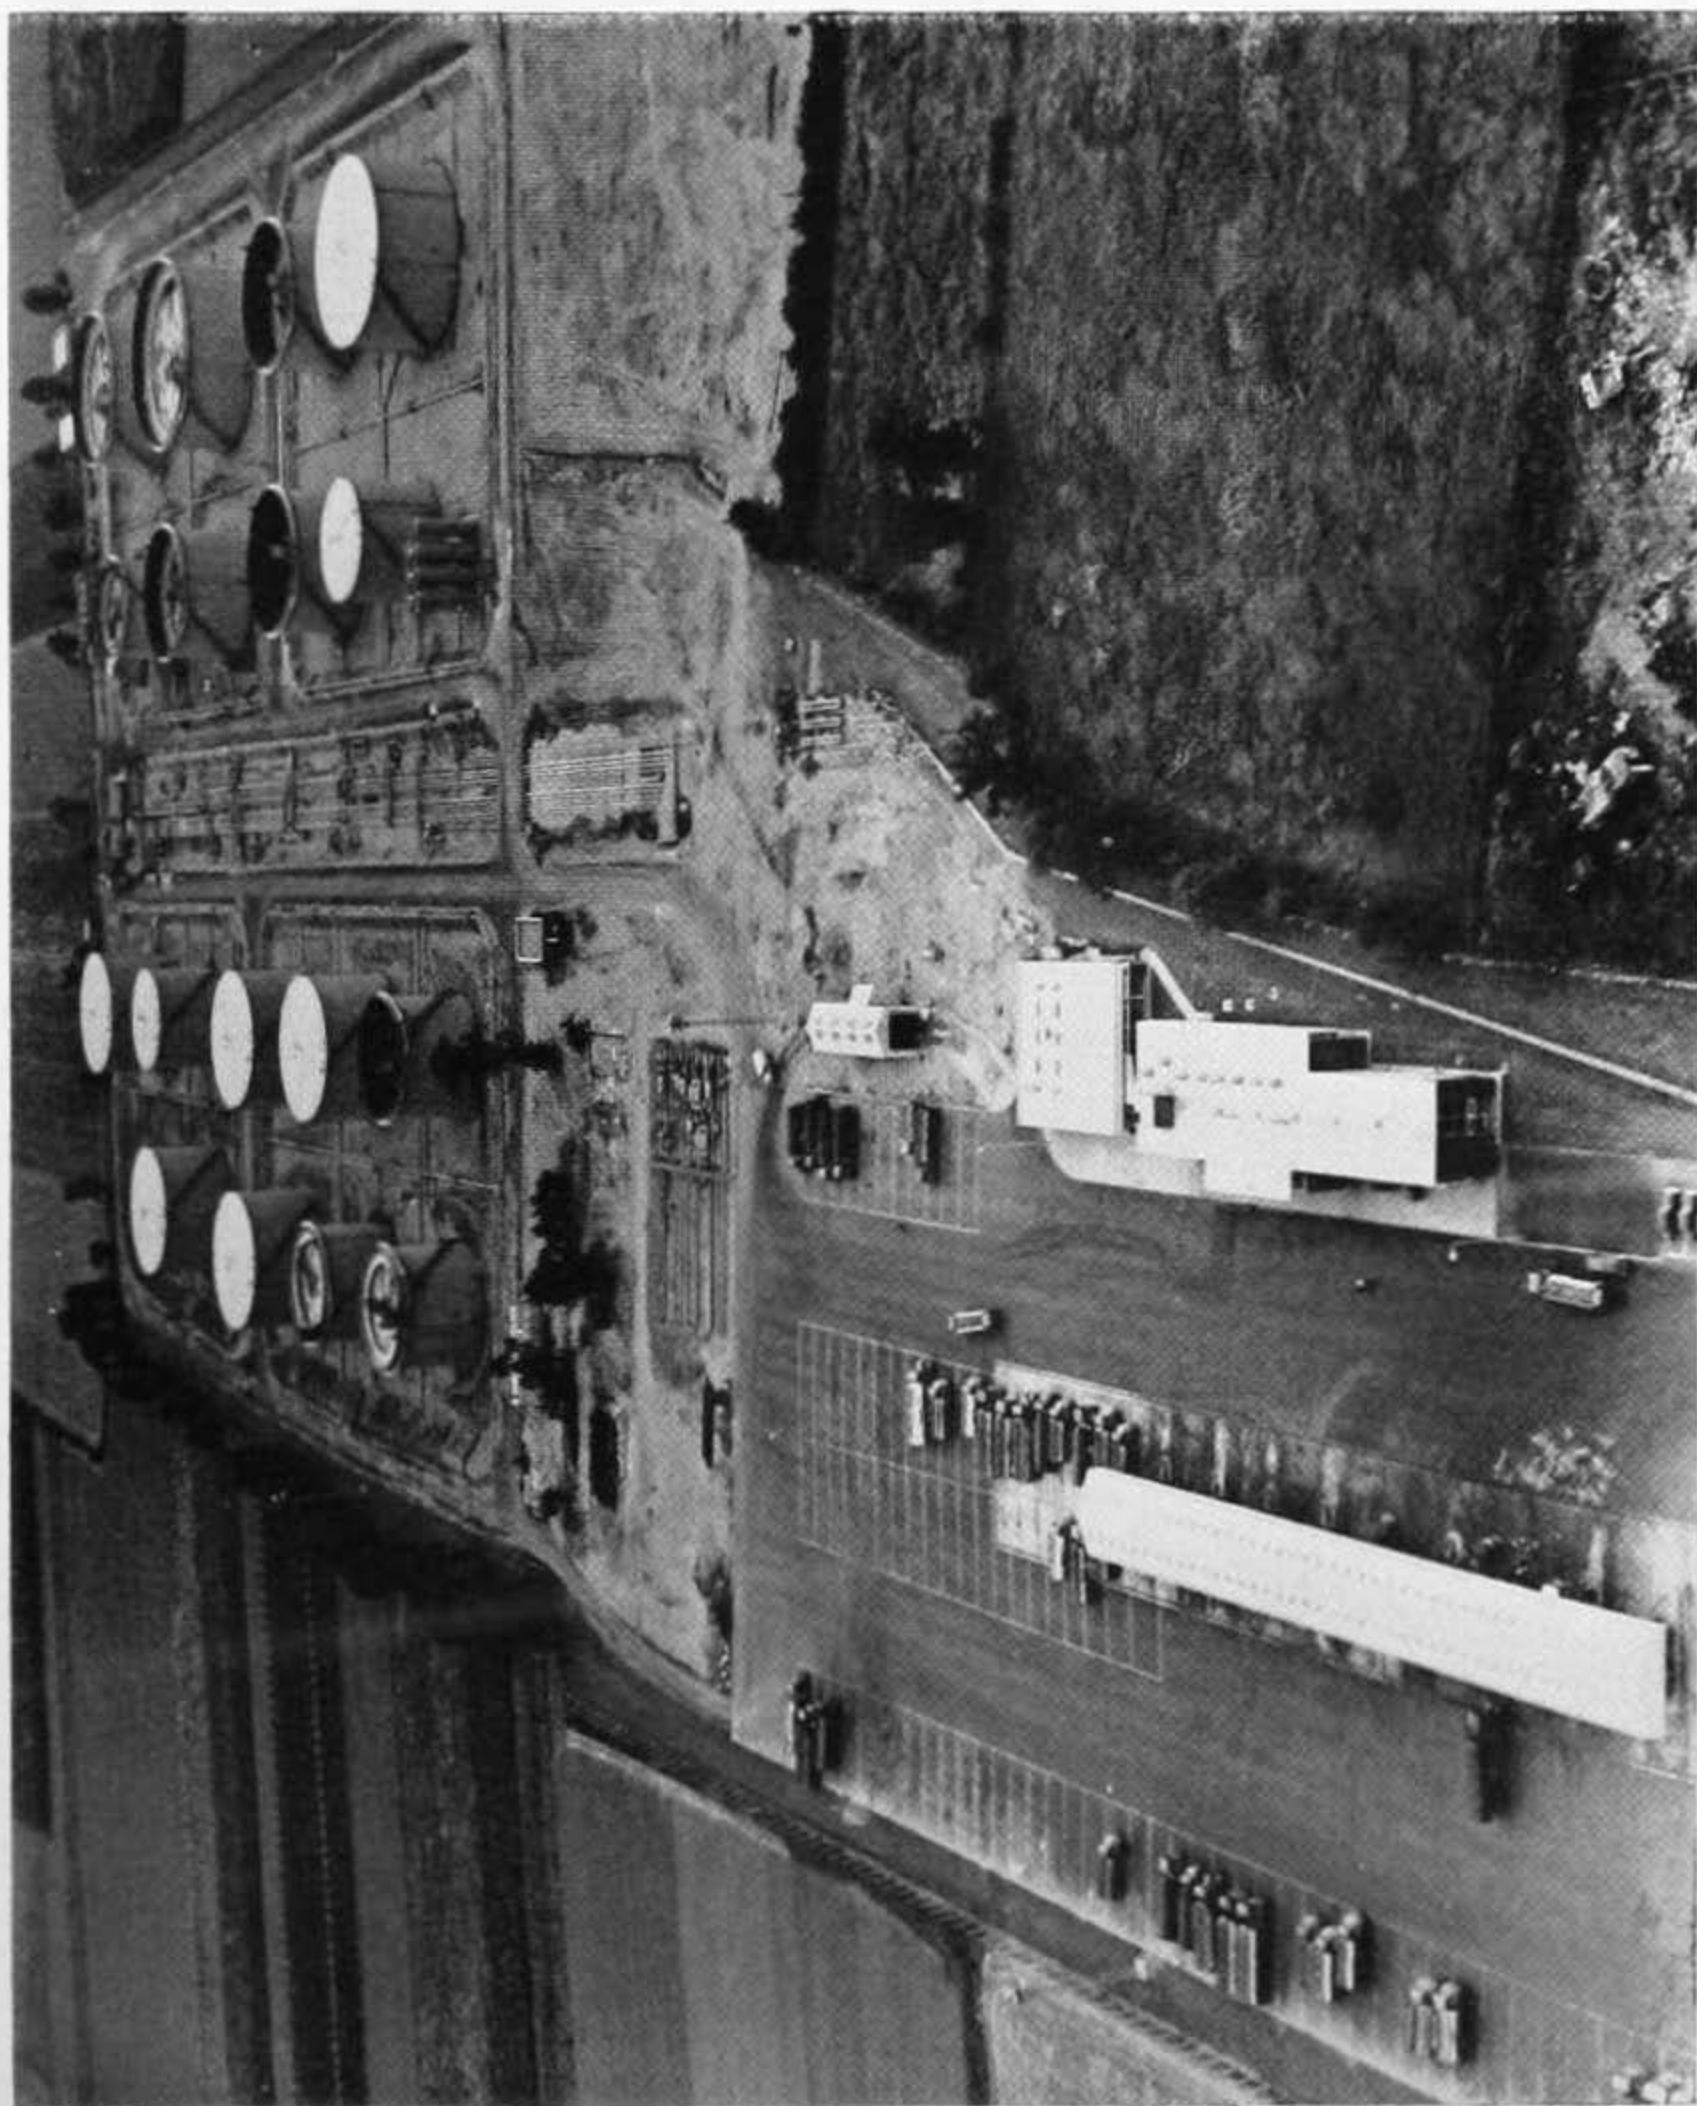
Plate No. 1

The premises of the Esso Petroleum Company Limited at Stanwell are known as the West London Terminal which is situated 14 miles west of London close to the southern perimeter of London (Heathrow) Airport. The eastern boundary of the flight path safety zone of the airport from No. 5 runway crosses the terminal towards the north-west; all places on the terminal where petroleum spirit is handled or exposed are outside the flight path risk zone from aircraft. The situation and the lay-out of the site are shown in Plan No. 1; an aerial view, which, in essential features, is the same as at the time of the accident, was taken in 1965 and is shown in Plate No. 1. The total site occupies about 33 acres.

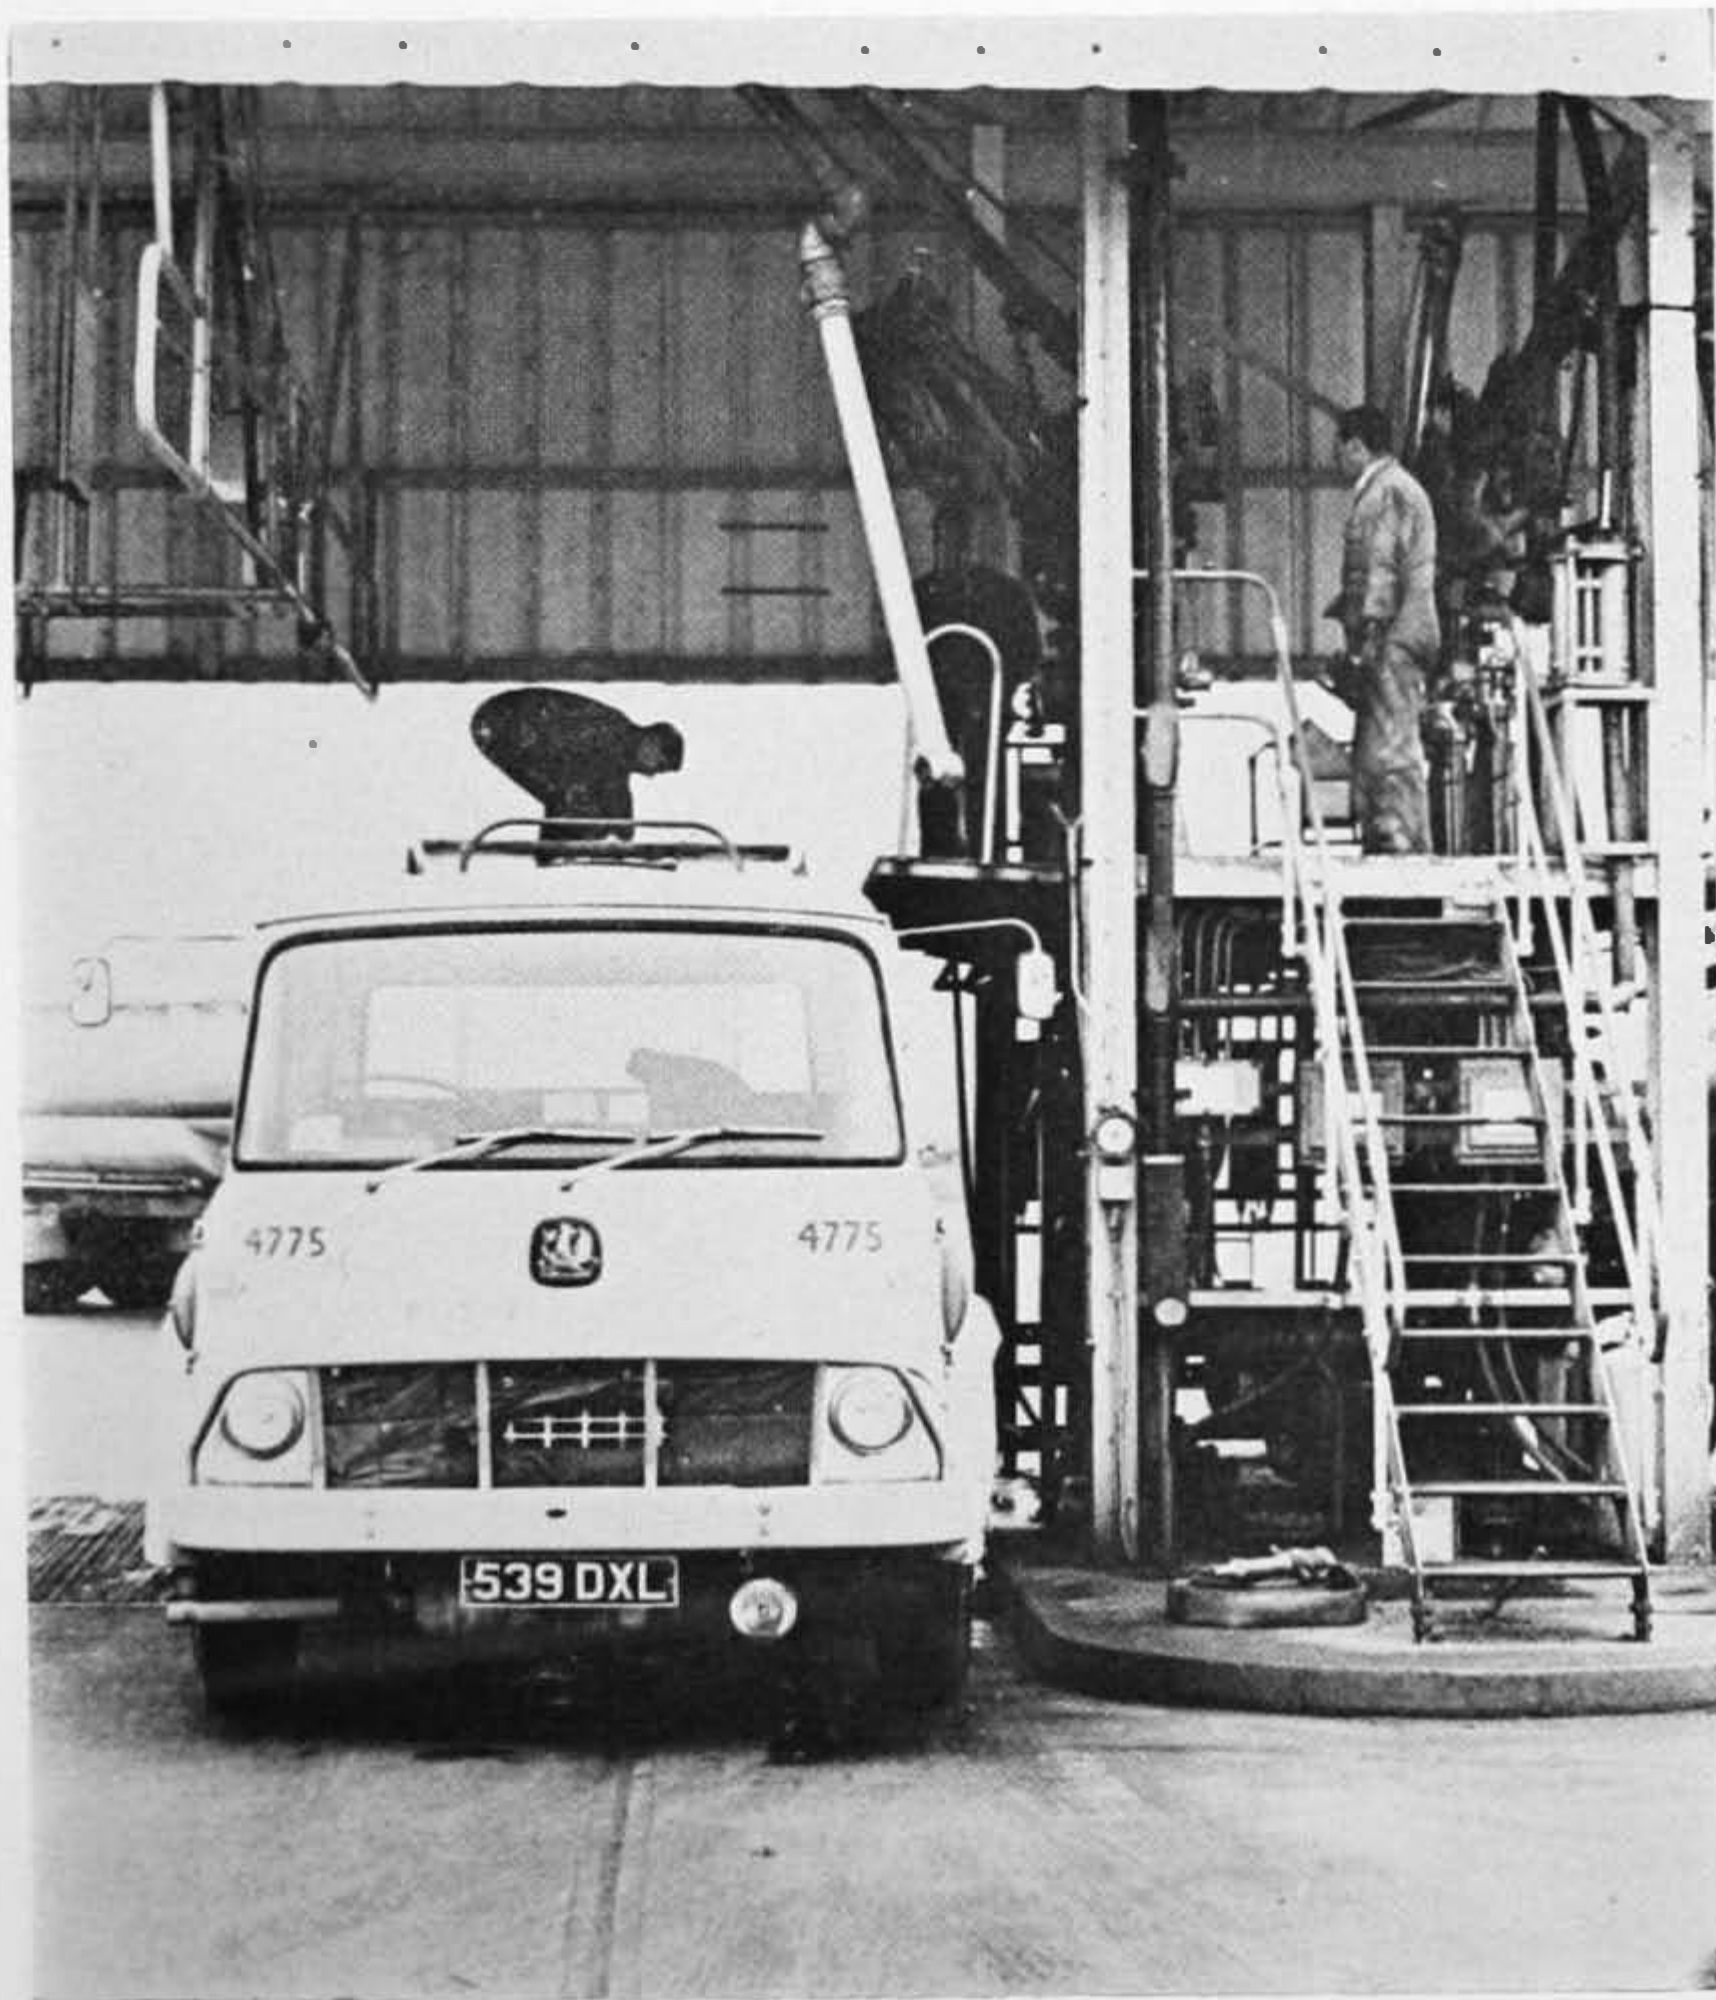
Plate No. 3

Products were taken by pipe-lines from the storage tanks to the base of each of the loading stands and thence via filters, control valves and meters to loading arms which were located on platforms accessible from the ground by means of iron steps (Plate No. 3).

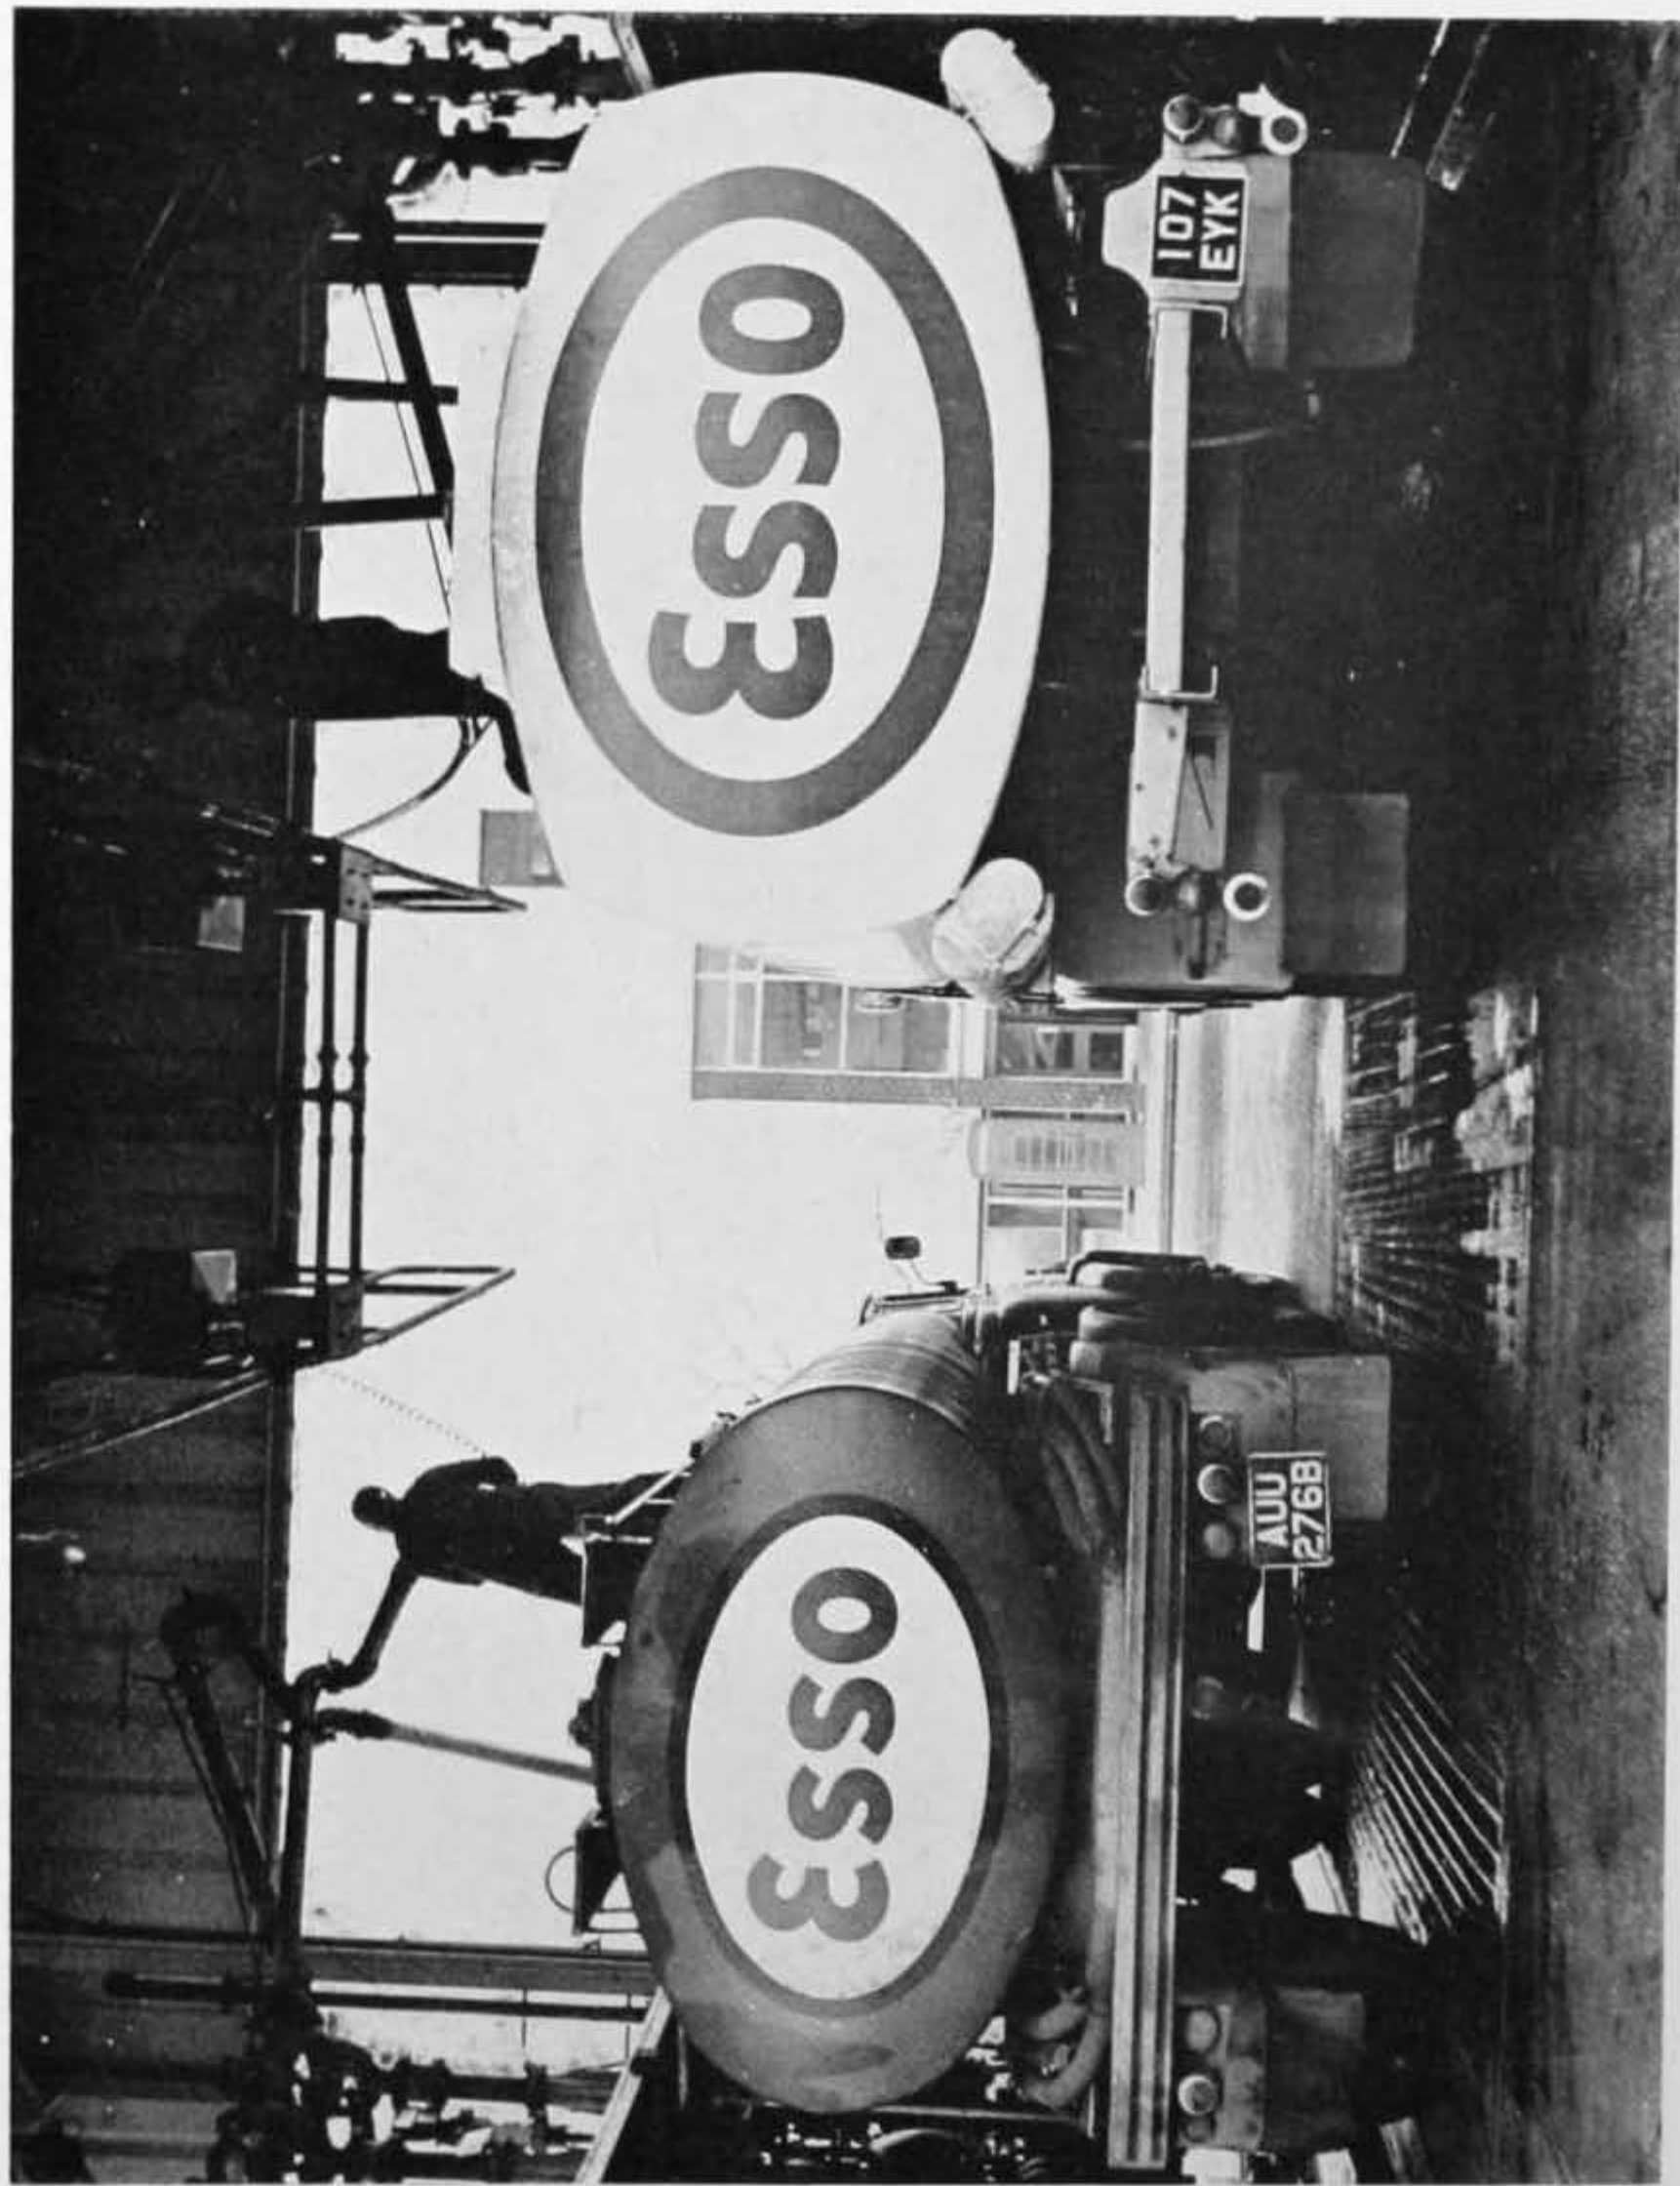
Plate No. 4

Each loading arm was designed to load at a maximum rate of 500 gallons per minute; a mercury switch on each arm actuated the pumps for product delivery when the arm was in the down (filling) position. Filling was accomplished, through open manholes, by the drivers standing on the cat-walks of the tanks of the vehicles at the same level as the loading arm platforms. Figure 1 shows the schematic arrangements of the loading arm; Plates Nos. 3, 4, 5 and 6 show the general filling arrangements and positions of vehicles at the loading stands.

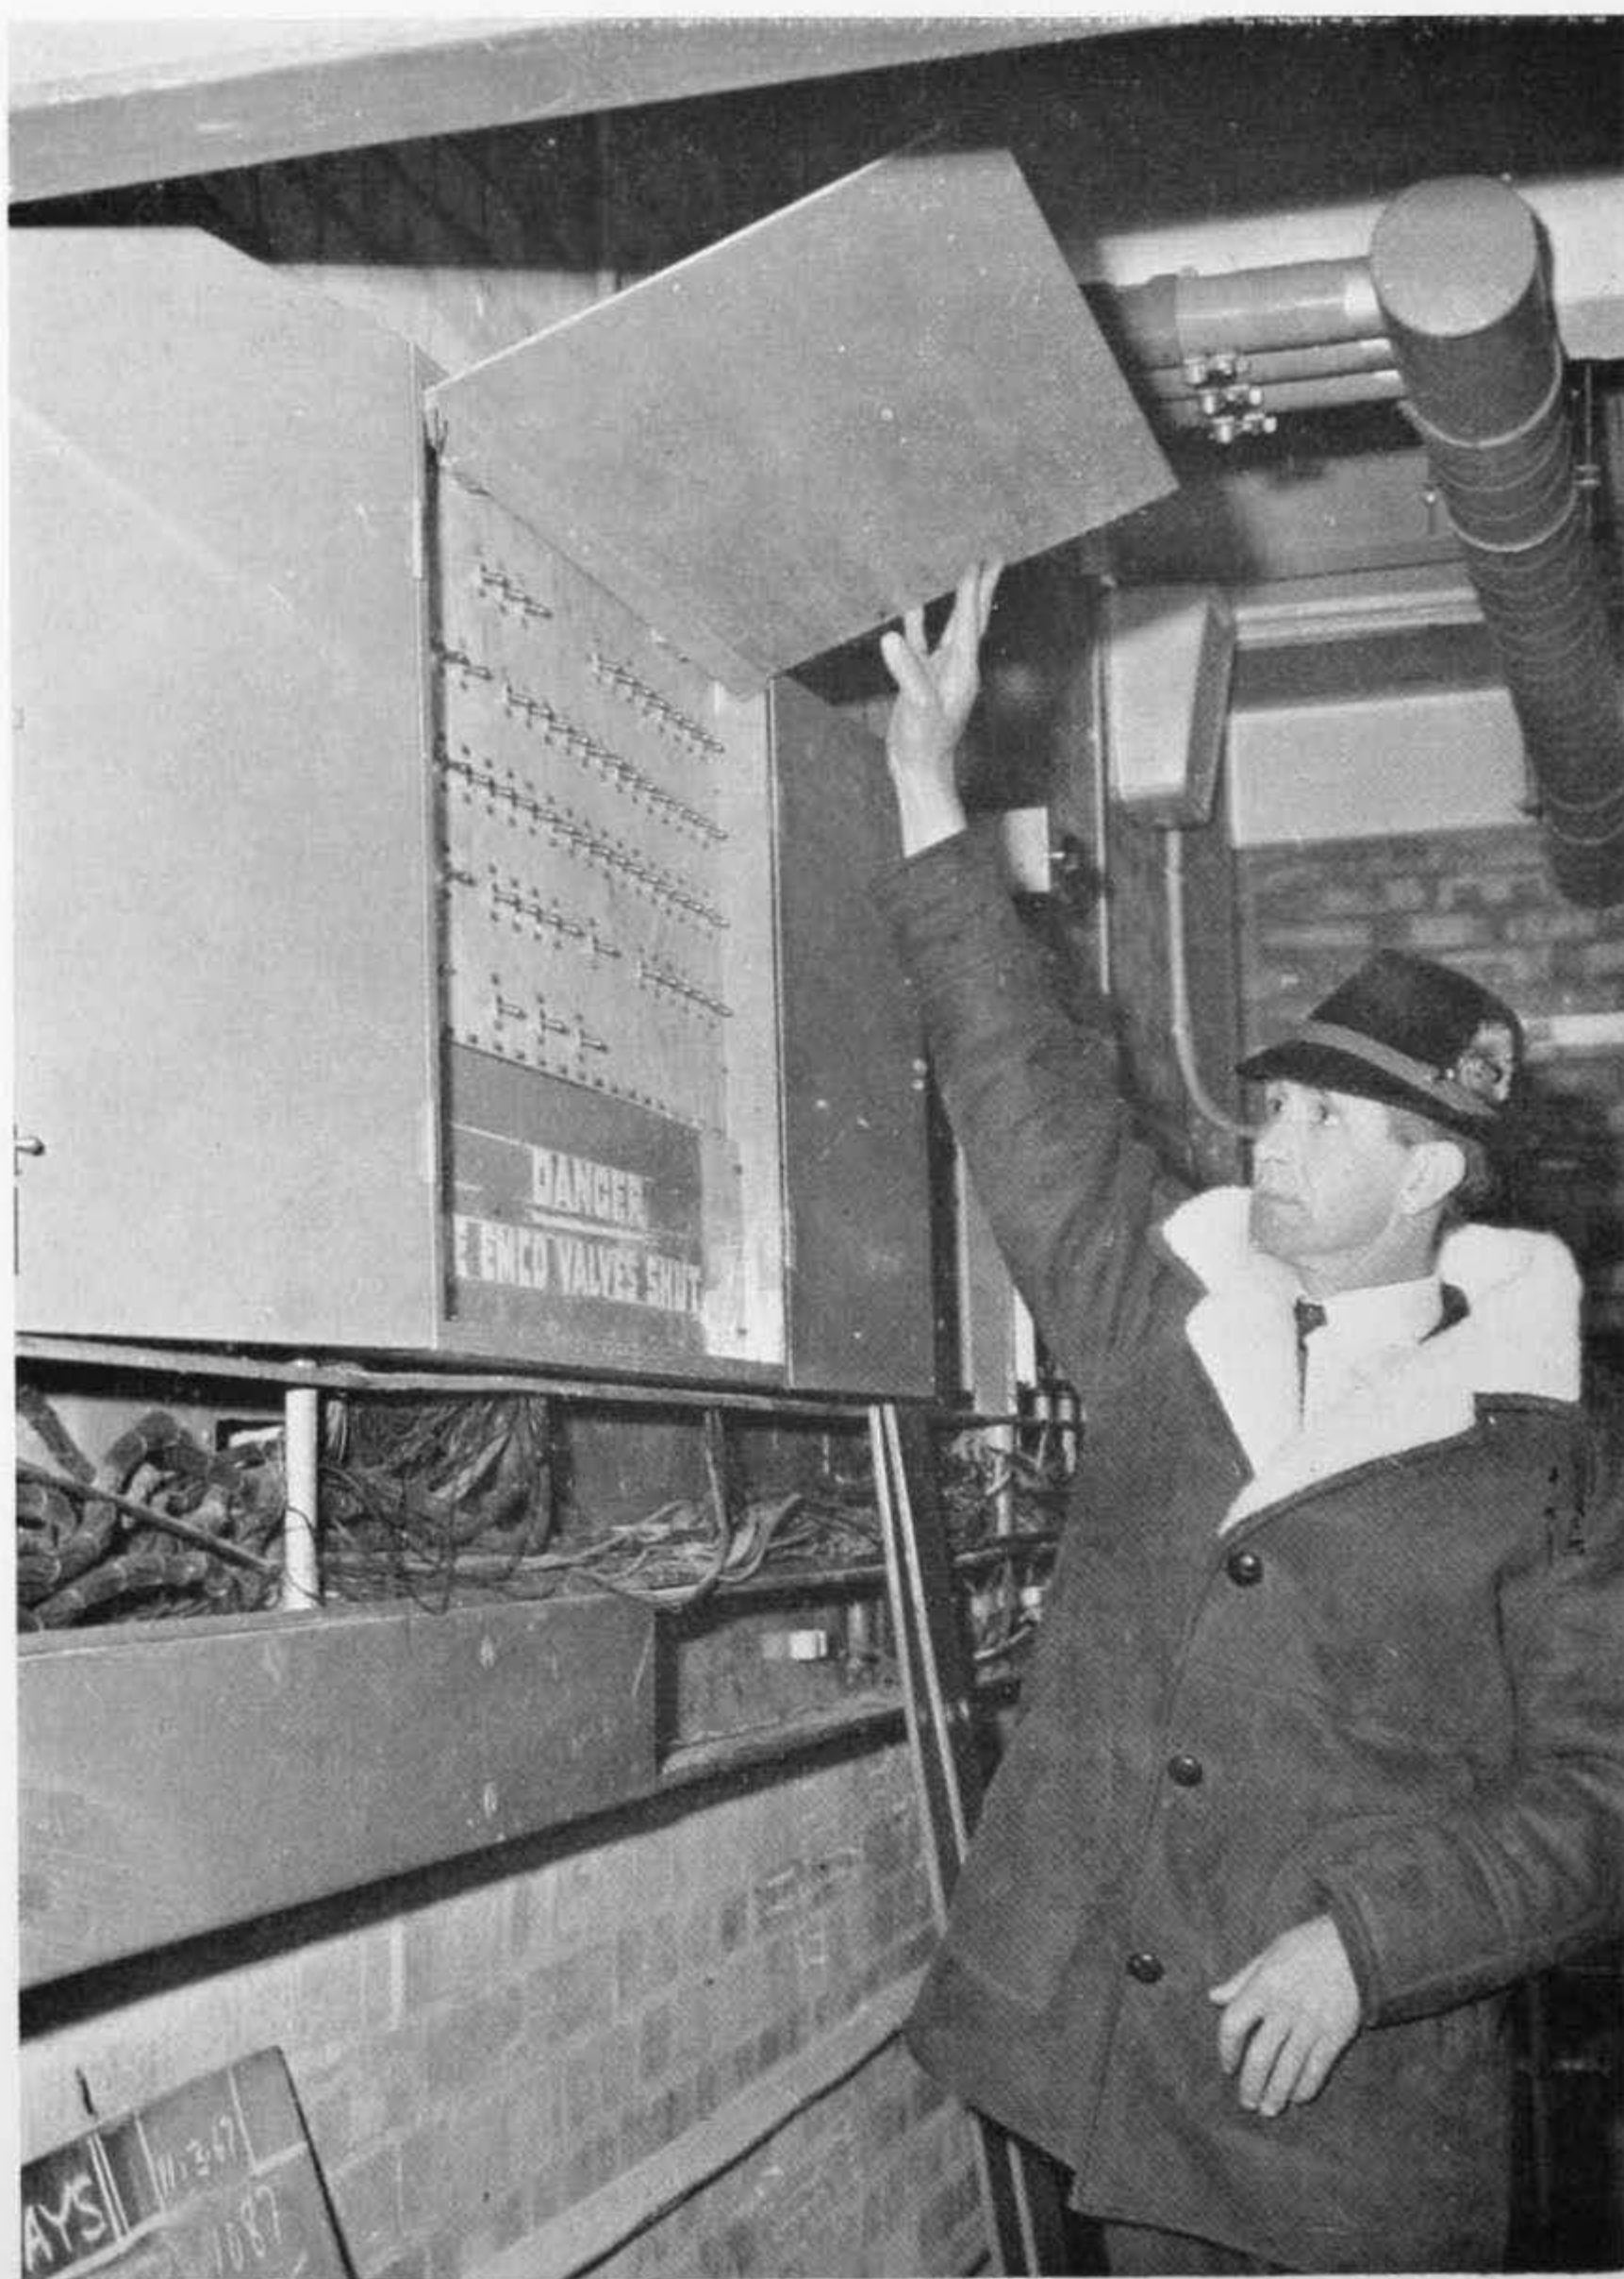
Plate No. 14

- (b) whereby a simple electrical switch for each loading arm served to energise solenoids which kept the automatic valve in the fully-open position. These switches were brought to a central switch-board mounted in the switch room. From this central switch-board all or any of the loading arms could be changed to manual control by operating the appropriate switches (Plate No. 14).

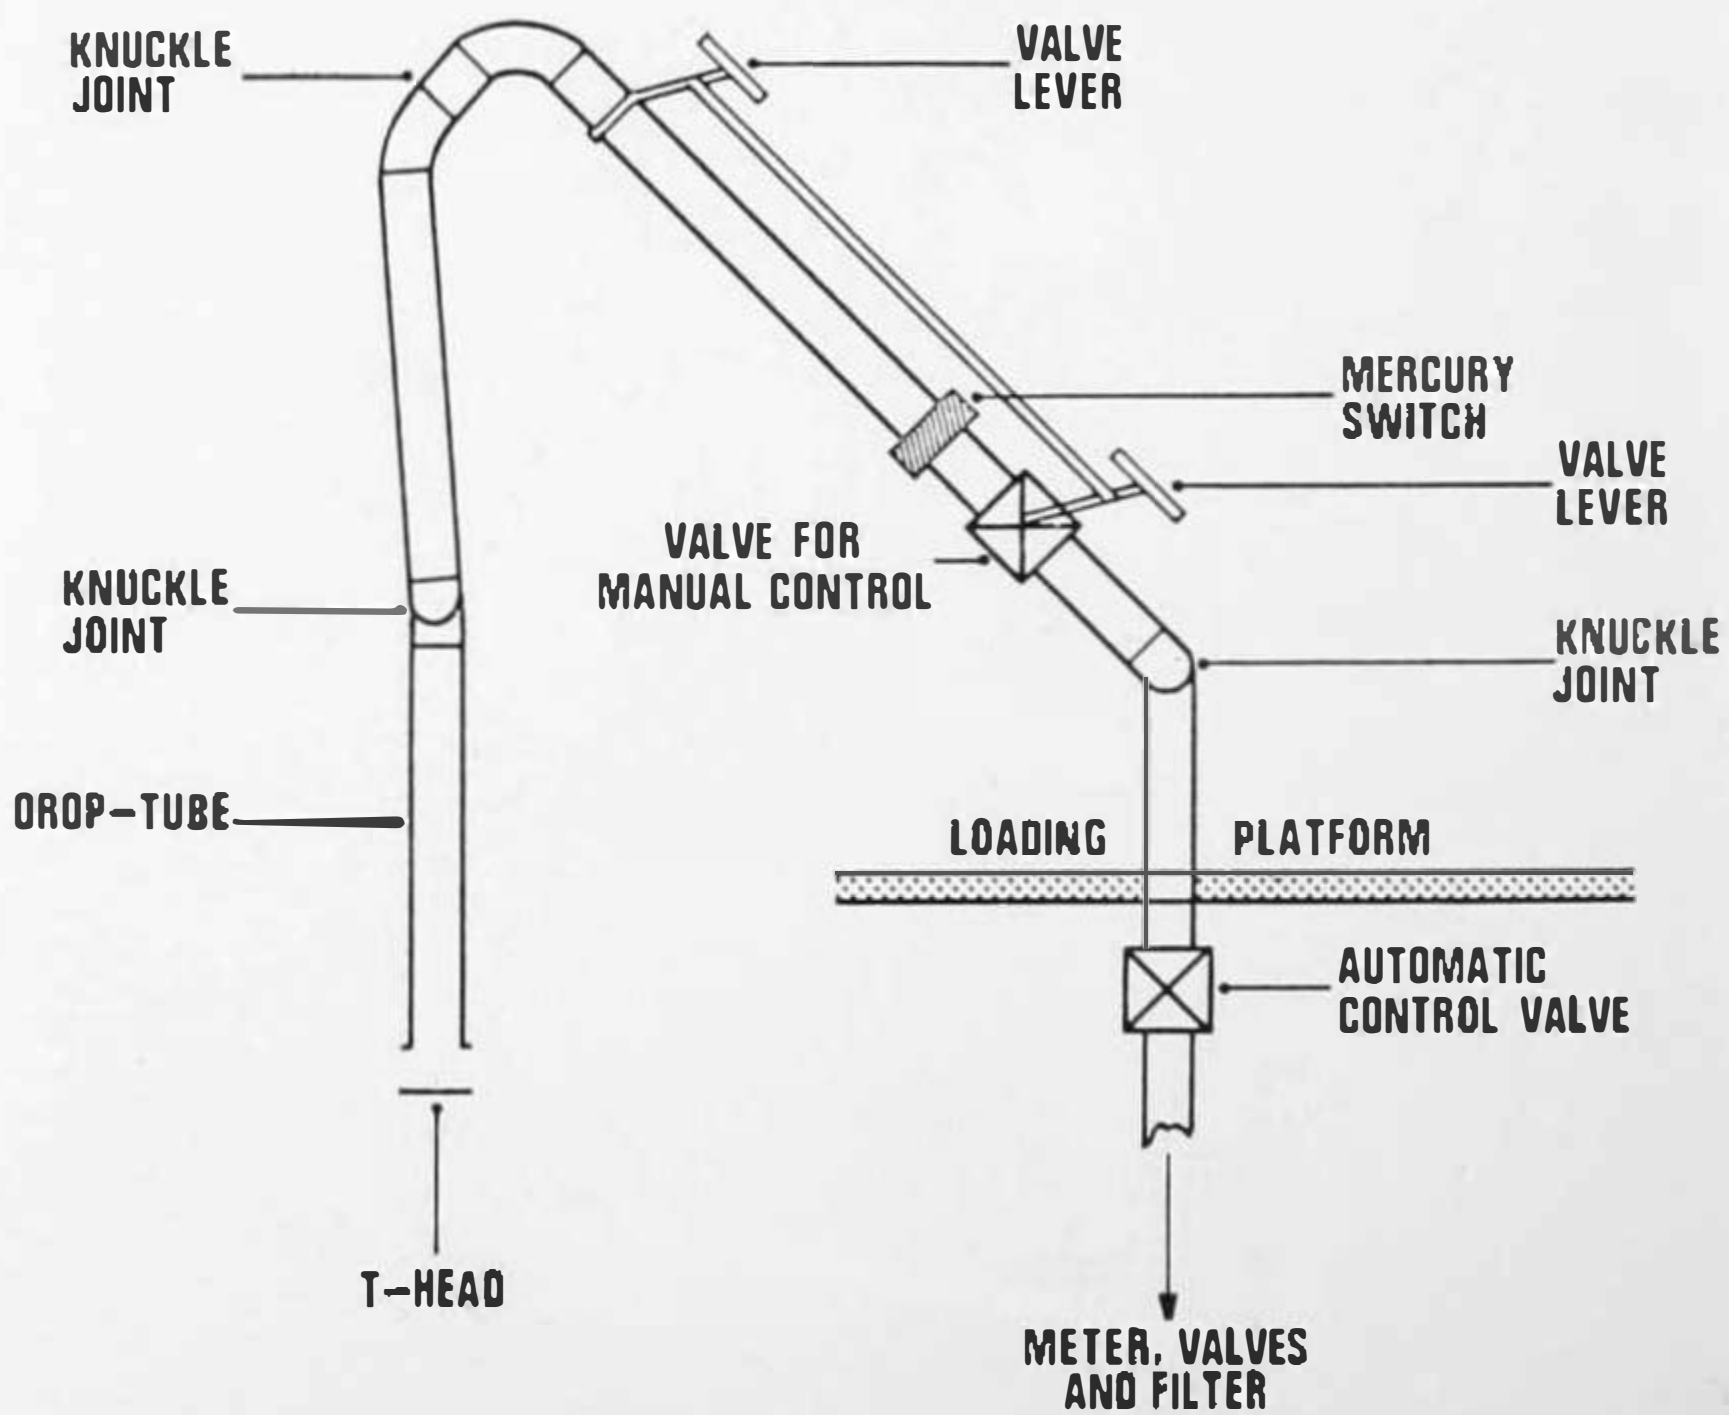
Figure 1

In the event of a fault developing in the automatic system which could not quickly be put right, provision was made to enable a change to be made to manual control. This meant putting the automatic valve out of action on each arm and incorporating in the loading arm a valve which could be operated manually (Fig. 1). This manual valve, which was infinitely variable so allowing full control of flow, was placed downstream of the automatic valve which in manual control had to be held wide open. Flow of product on manual control then came directly under the control of the driver through the manually operated valve. In use it had physically to be held open against a spring; when the driver released the valve-lever the valve closed of itself and hence the lever functioned as a dead-man's handle.
